Subject: Brake Fluid Exchanger BF-12 code MM: 007935016730.

Incorrect work tools to exchange brake fluid in a car. Issue with no vacuum and not to moving fluid out of cylinder to car.

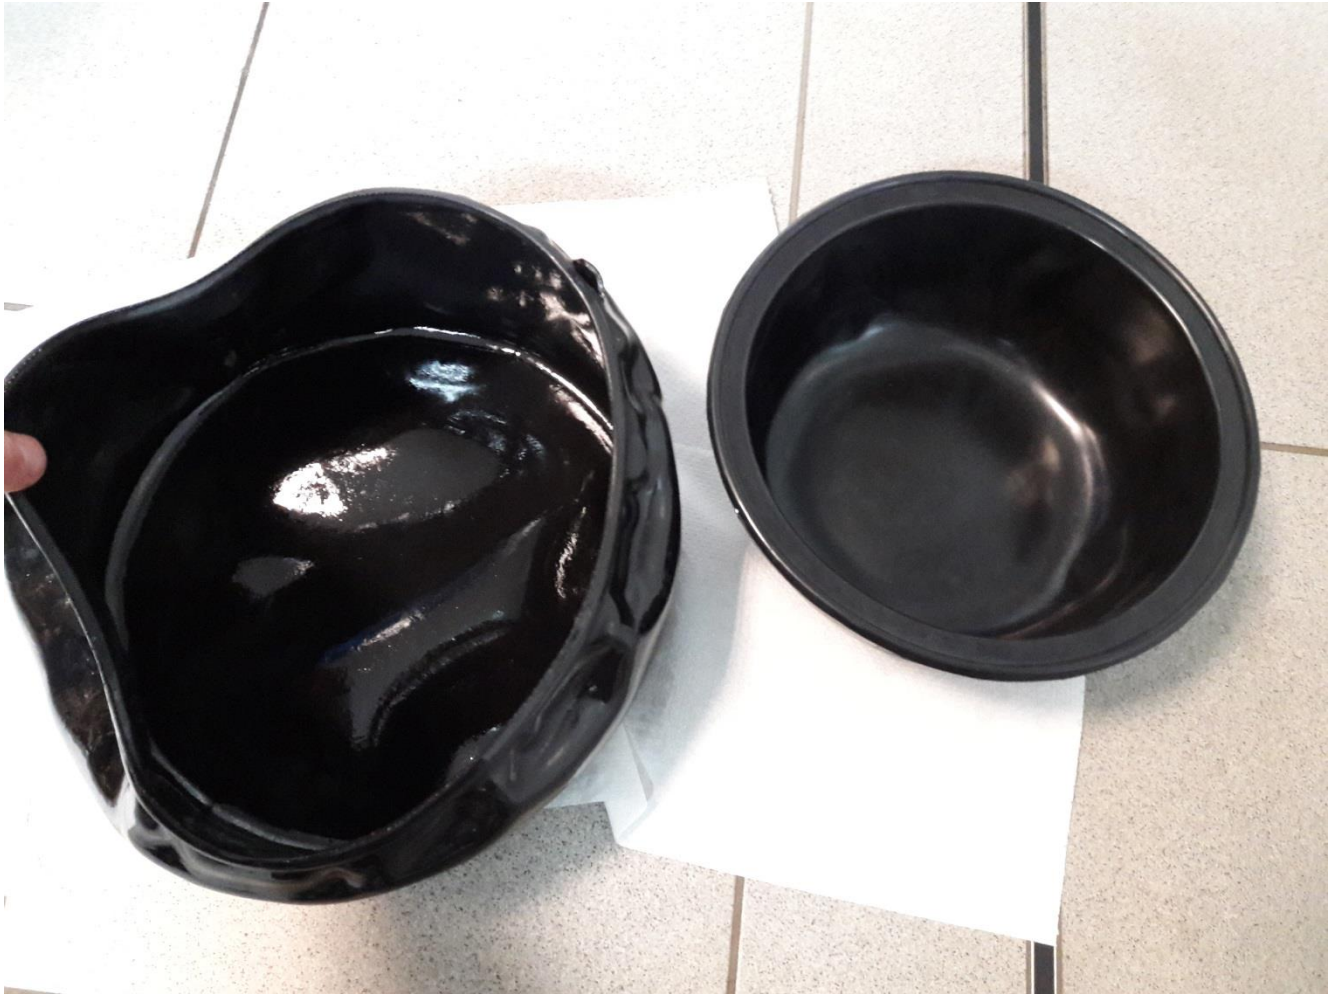
The reason for running may be a damaged or worn rubber membrane inside the tank.
Below are the comparative results for the new membrane.

The membrane is available as a spare part in the Magneti Marelli offer under the code: 7935016910

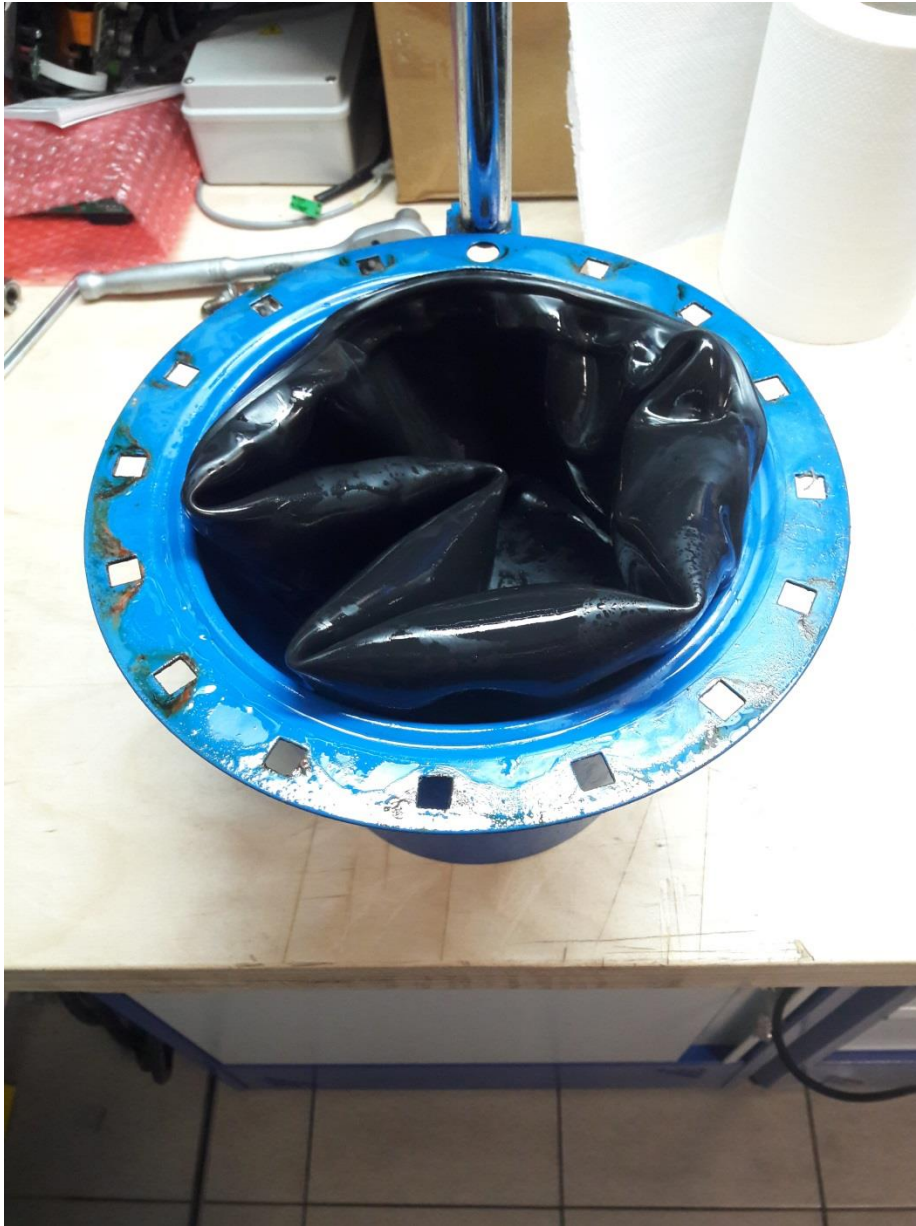
After opening the device, the damaged membrane looks as follows:

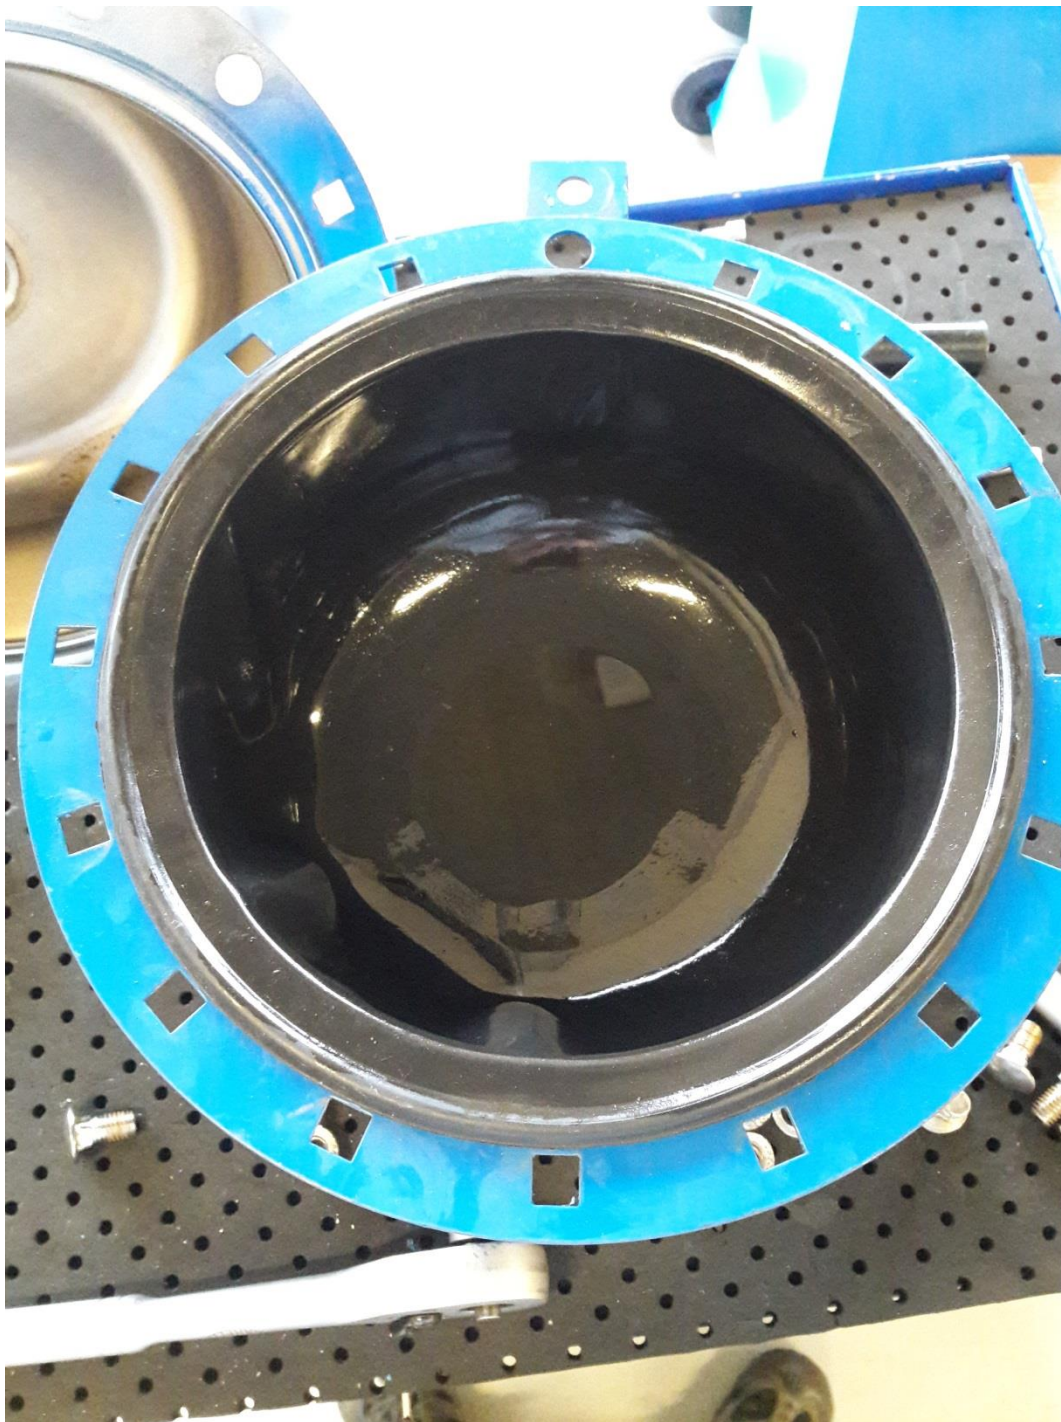
Properly seating of membrane inside should be looks like on picture below:
